Confidential Inspection Report

**123 Anywhere St.
Burlington, ON**

December 10, 2012

Prepared for: John And Jane Smith

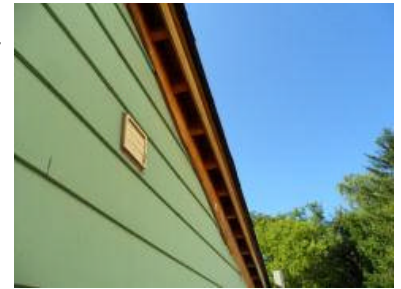
Trim Condition:

Attention Needed - Some portions of the trim boards need painting to prevent further deterioration.

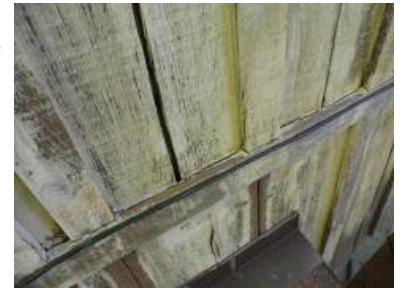
Condition of Painted Surfaces:

Attention Needed - The exposed painted surfaces need some minor attention or touch-ups to make the surfaces weathertight. These repairs should be scheduled soon to prevent further deterioration.

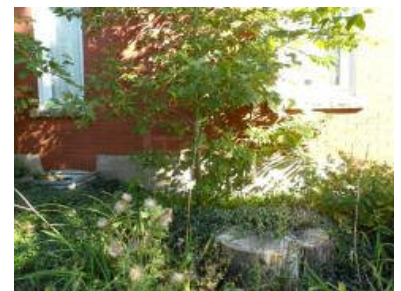
Bushes and Shrubs Condition:

Attention Needed - The shrubs and/or bushes need to be trimmed or maintained.

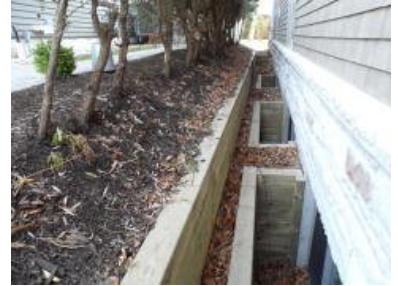
The retaining wall is made of wood. It appears to be treated wood.

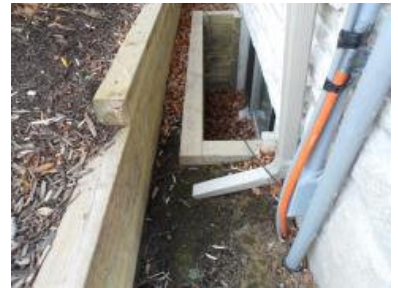
Water Drainage:

Attention Needed - The run-off water below the retaining wall needs to be redirected away from the wall.

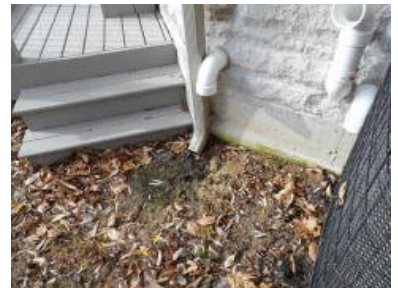
Action Necessary - The downspouts are in need of adjustment in order to better divert water away from the home. Ideally the water should be discharged at least 6 feet away. In areas where space is restricted, do your best to get it away as far as you can.

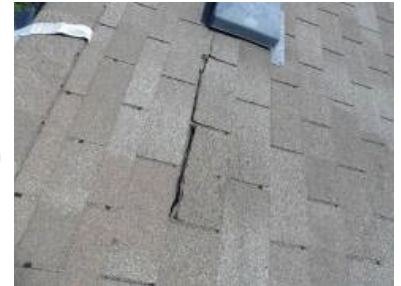
Condition of Roof Covering Material: **Attention Needed** - This roof has signs of aging and a reduced remaining service life. Attention is needed now to prolong its service life. We observed the following indications of wear and need for maintenance: Some of the shingles had been loosely nailed down and may blow off again in heavier winds.

Estimated Life Expectancy of Roof: The roof covering material appears to have a remaining life expectancy of 3 to 5 years, assuming proper maintenance is completed as needed.

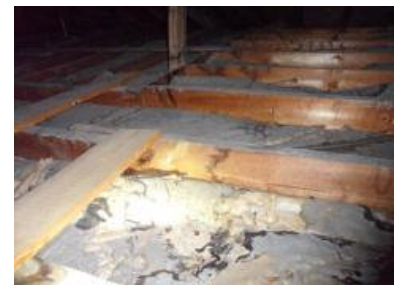
Insulation Noted: The following type of insulation was noted in the attic: Fiberglass: Batts. There is an average of at least 4" of insulation installed. **Action Necessary** - The attic insulation appears to be insufficient to properly insulate the living spaces below.

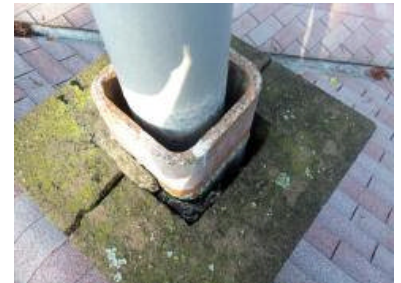
Fuel: Wood - The fireplace is designed to burn wood.
Firebox Condition: Satisfactory - The firebox appears to be sound and useable in its current condition.
Flue Condition From Roof: **Attention Needed** - The fireplace flue, as viewed from the roof, is unsealed at the flue opening.
